Reliability of Nondestructive Tests on Damage Assessment of Mosul Museum Building after Liberation Events

3. MOSUL MUSEUM PRIOR DAMAGE

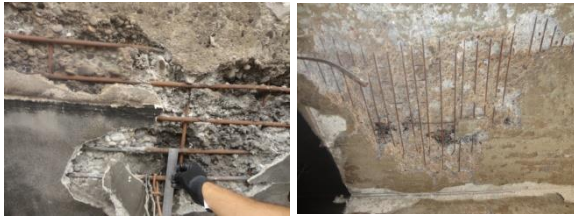
Fig. 3 Damaged concrete cover for slab reinforcements in the library hall.

Fire at the basement floor: The library was burnt during the liberation of Mosul, June 2017. Burning this library was part of the master plan of setting a large part of the city of Mosul on fire. The zone surrounded between grids 'F' to 'L' intersects with grids '1' to '5' (Figure 2) was severely burned out. The fire damaged the concrete cover for slab

reinforcements, as shown in Figure 3. Some beams were severely affected by heat, and shear cracks were noted at several locations, as shown in Figure 4, (e.g. beams located along grid '1' and between grids '2' to '4'). To check the concrete status at the core of the beam, a small chip of concrete was gently removed, as illustrated in Figure 5 and it was noted that the concrete color has been changed due to the heat.

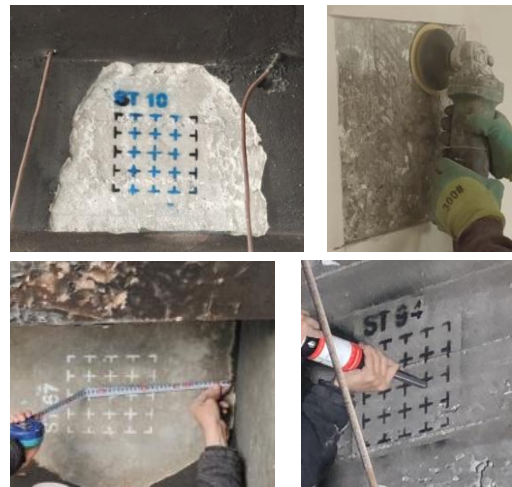
Fig. 6 Arrangements for hammer test at each station.

Schmidt Hammer Tests are used to assess concrete compressive strength. This test was performed on more than 100 different locations around the structure, footings, columns, beams, slabs etc. Before the test, each station is cleaned and the concrete face is smoothen with grinding machine and abrasive sandsheet, as illustrated in Figure 6. At each station, 16 sampling points were measured and tabulated. Then, the standard deviation was calculated, the deviations of individual sample readings showed minor deviations.

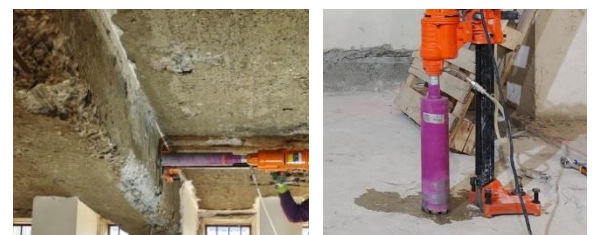
a) Core B at beam b) Core D at slab
Fig. 10 Cores sampling.

B, E and C, F were 75mm diameter cores collected from basement beam and column, respectively. Figure 10 shows the sampling of B and D cores. All the destructive core samples were done, satisfying ACI 214.4R [22] code requirements.

Lab results show that the density of the concrete is classified as normal concrete density for all tested samples and that the severe heat did not show any notable impact on the concrete density. The strength of the destructive core samples at the library

shows significant reduction in its strength, as illustrated in cores results in D and B samples for slab and beam (f_c less than 10MPa).

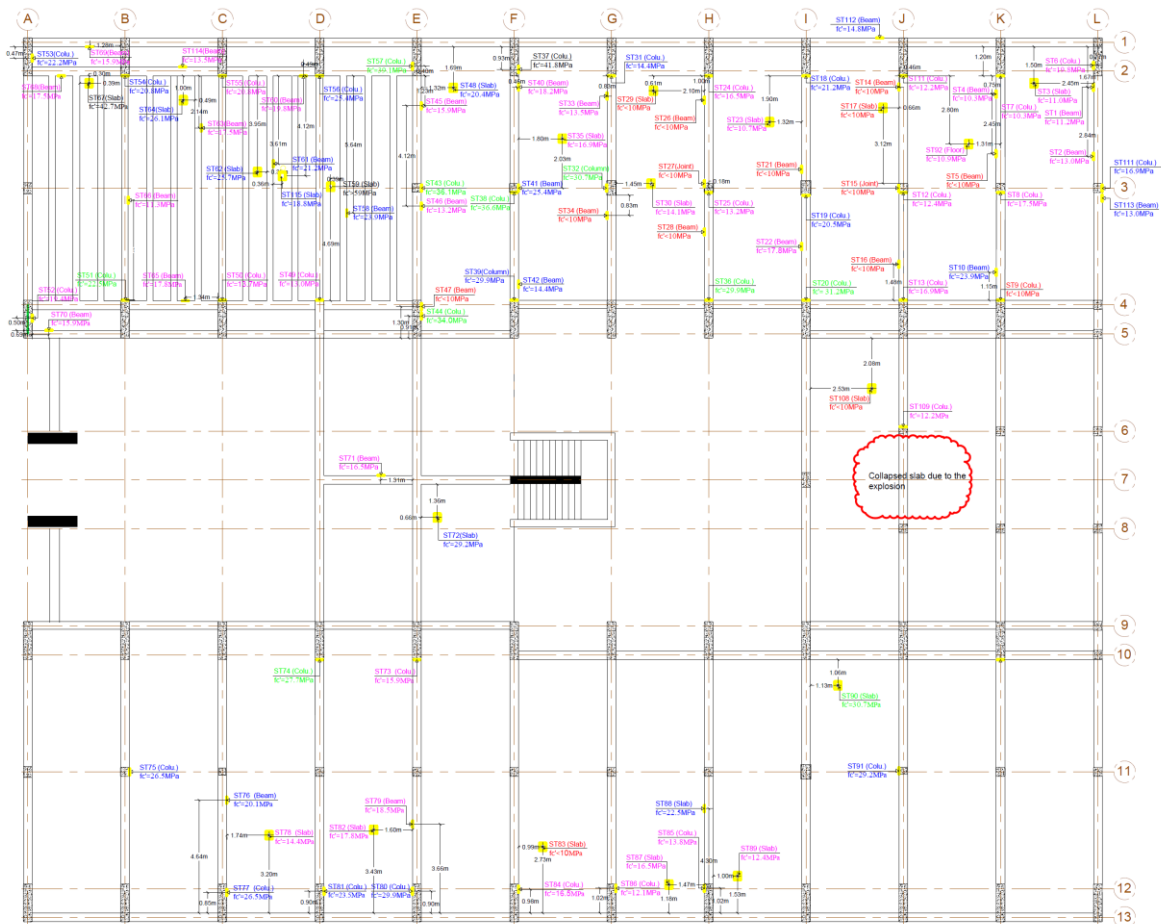
Fig. 12 Calibrated NDT strength results in the burned concrete at the basement.

Figure 12 displays the complete calibrated strength of the burned concrete at the basement level of the museum. A significant difference between

calibrated strength with the predicted NDT test results (un-calibrated NDT strength results displayed in Figure 8) is noticed. The heat calibration factor evaluates for strength degradation at various heat levels. It almost exactly matches the distractive core test in stations ST19, ST26 and ST92 (Table 3). By comparing both calibrated and un-calibrated NDT results in Figures 16 and 20, the adopted assessment can be quite different and it deviates significantly when the heat factor is considered.
